Amosite Demo Customer
Warehouse
Demonstration
Demonstration
Demonstration

Survey Date: 01/09/2016
Survey Ref: POTWLM

Asbestos Management Survey Report

THIS MANAGEMENT SURVEY WAS COMPLETED ON 01/09/2016 AND THIS REPORT WAS COMPILED ON 02/09/2016
SITE REFERENCE POTWLM

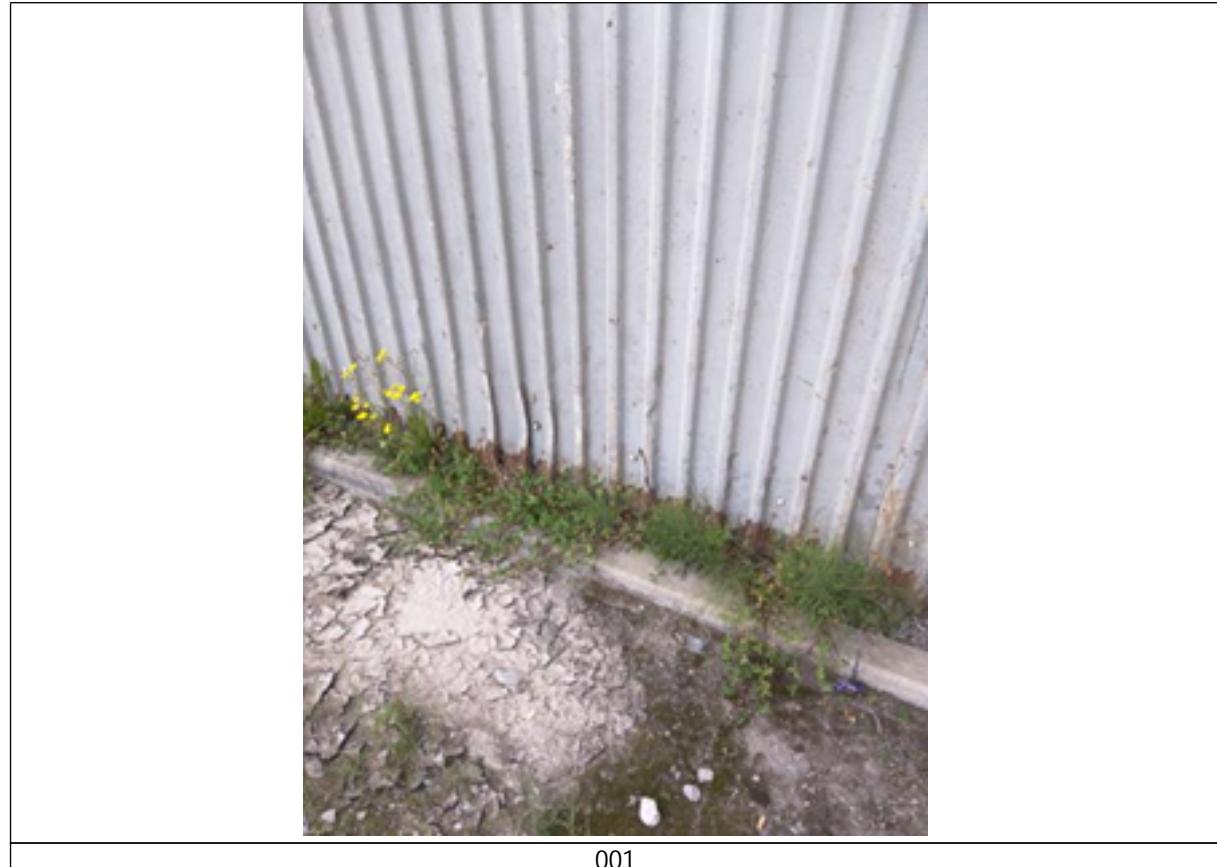
Asbestos Type	Chrysotile
Product Type	Galbestos
Condition	Low Damage
Surface Treatment	Composite Materials
Material Risk Score	3

Surveyors Comments	
<p>These Galbestos wall cladding sheets, which are damaged at low level, contain Chrysotile asbestos. It is recommended that these are encapsulated, then these should be managed on an annual basis via an asbestos management plan.</p>

CHRYSTOILE WAS DETECTED IN THIS SAMPLE

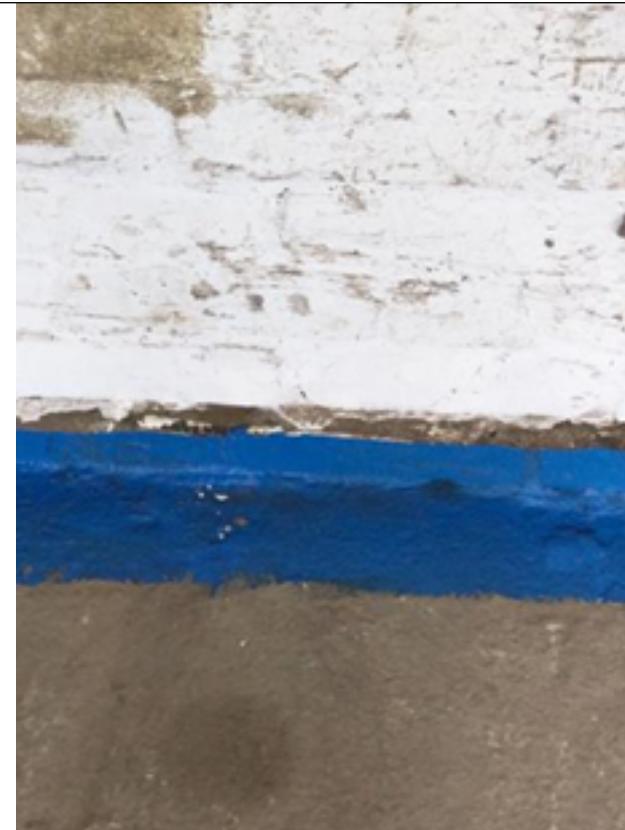
002

Asbestos Type	NADIS
Product Type	Damp Proof Course
Condition	Not Applicable
Surface Treatment	Not Applicable
Material Risk Score	N/A

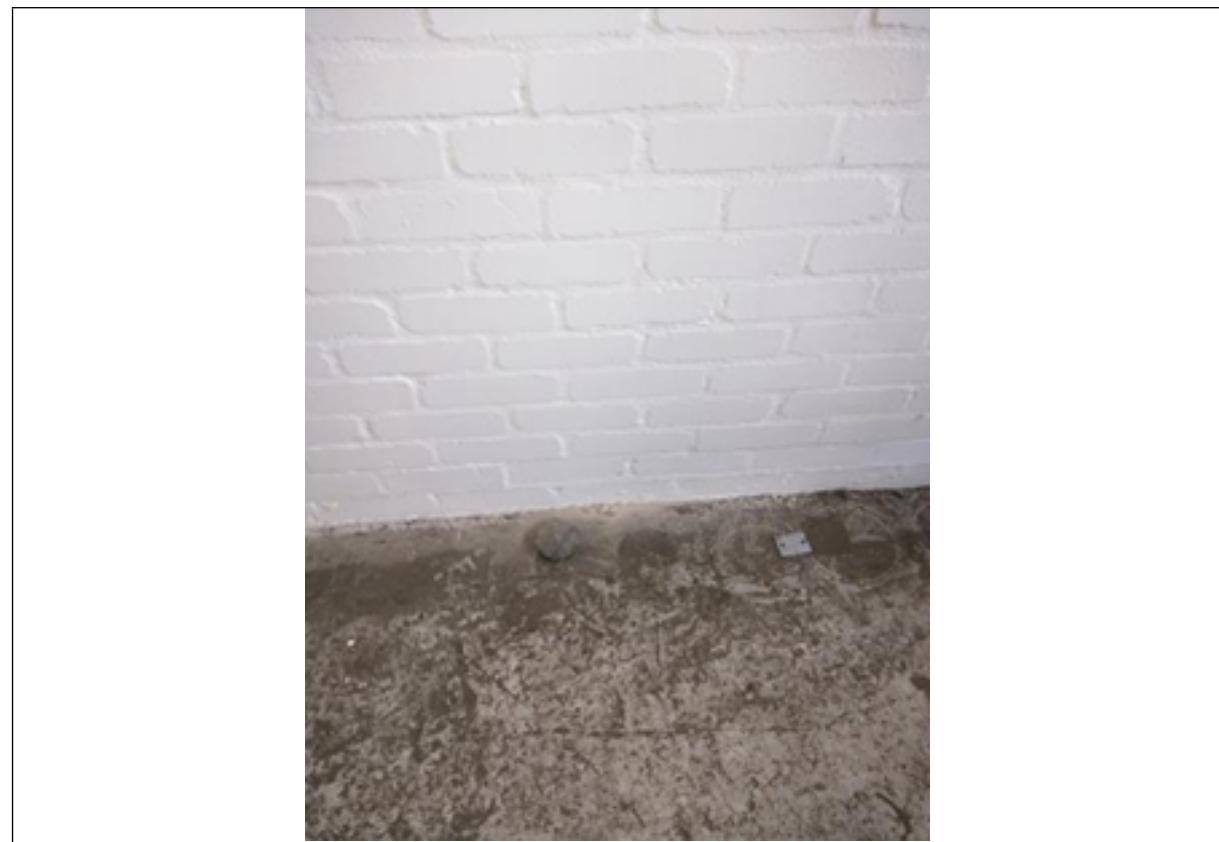
Asbestos Type	NADIS
Product Type	Damp Proof Course
Condition	Not Applicable
Surface Treatment	Not Applicable
Material Risk Score	N/A

Surveyors Comments
N/A - NADIS

NO ASBESTOS WAS DETECTED IN THIS SAMPLE

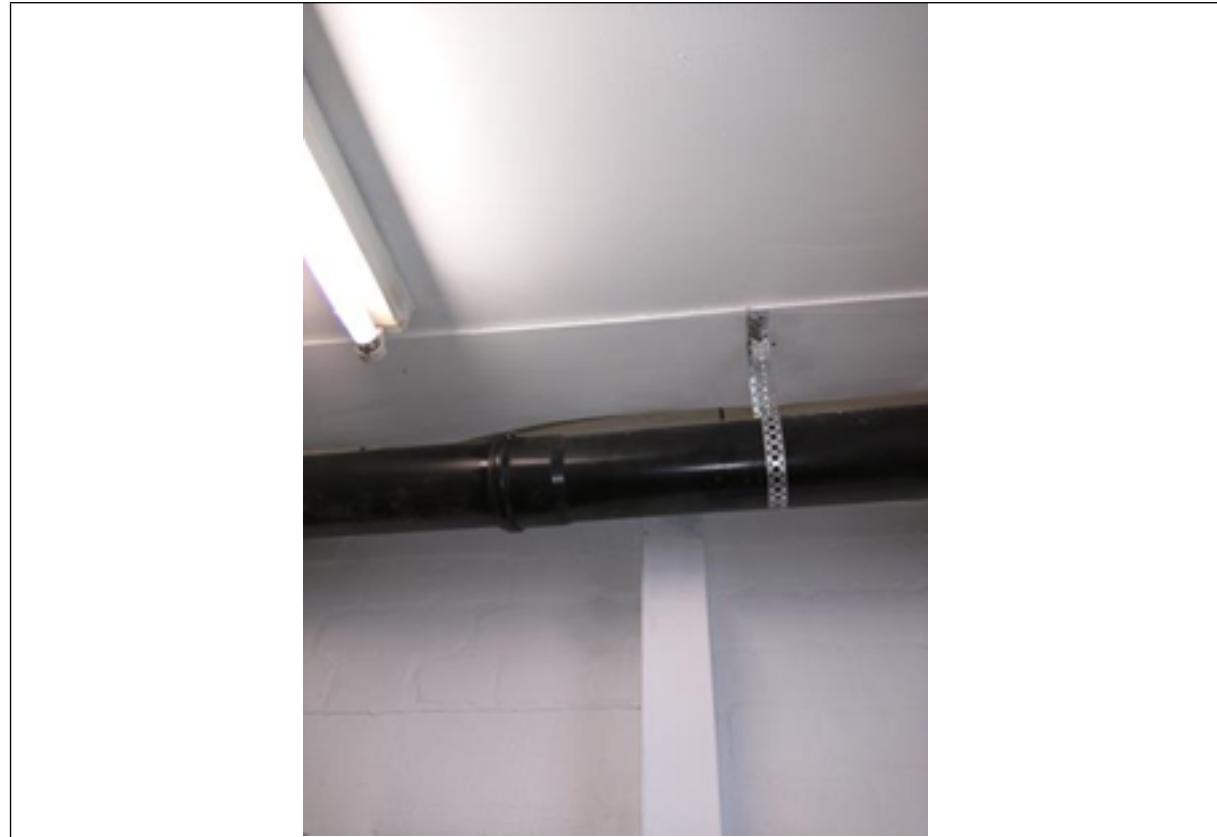
Asbestos Type	NADIS
Product Type	Ceiling Cement Board
Condition	Not Applicable
Surface Treatment	Not Applicable
Material Risk Score	N/A

Surveyors Comments
N/A - NADIS

NO ASBESTOS WAS DETECTED IN THIS SAMPLE

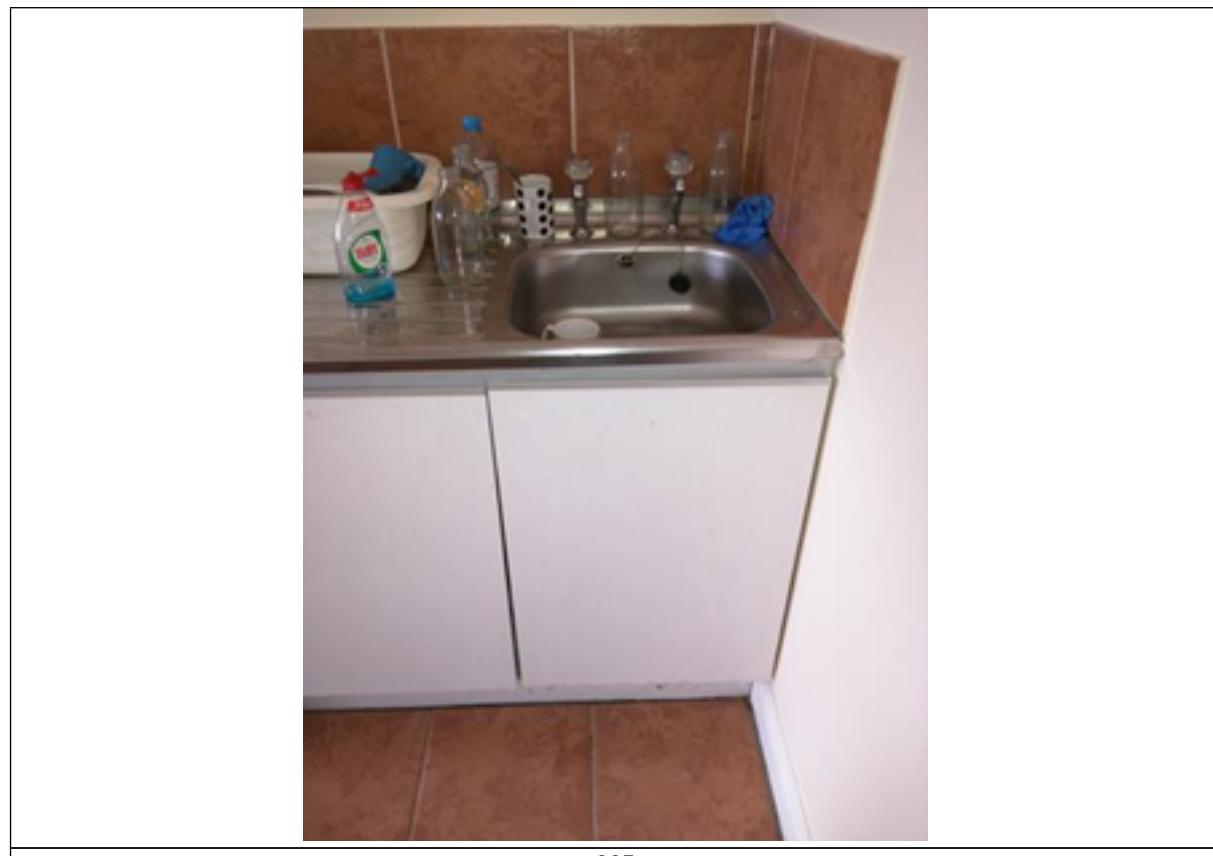
Asbestos Type	NADIS
Product Type	Sink Pad
Condition	Not Applicable
Surface Treatment	Not Applicable
Material Risk Score	N/A

Surveyors Comments	
N/A - NADIS

NO ASBESTOS WAS DETECTED IN THIS SAMPLE

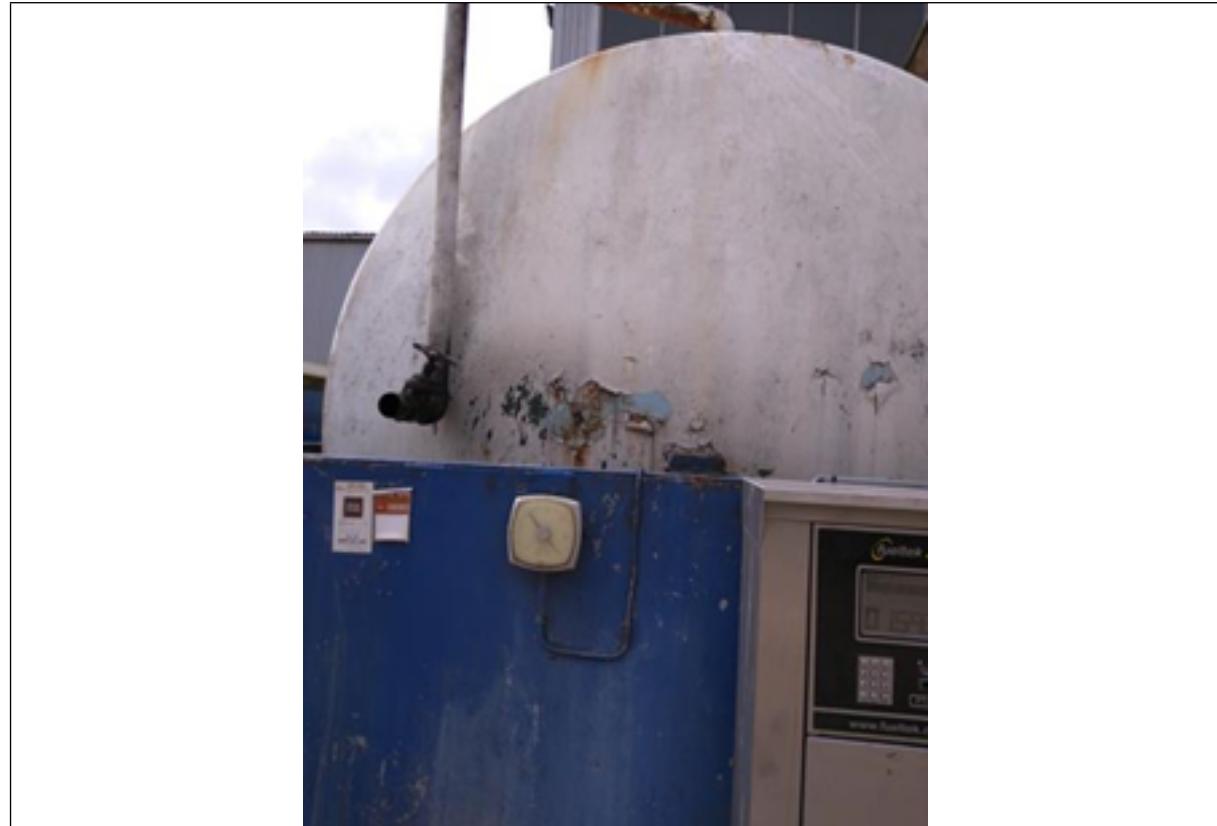
006

Asbestos Type	NADIS
Product Type	Paint
Condition	Not Applicable
Surface Treatment	Not Applicable
Material Risk Score	N/A

Surveyors Comments	
N/A - NADIS

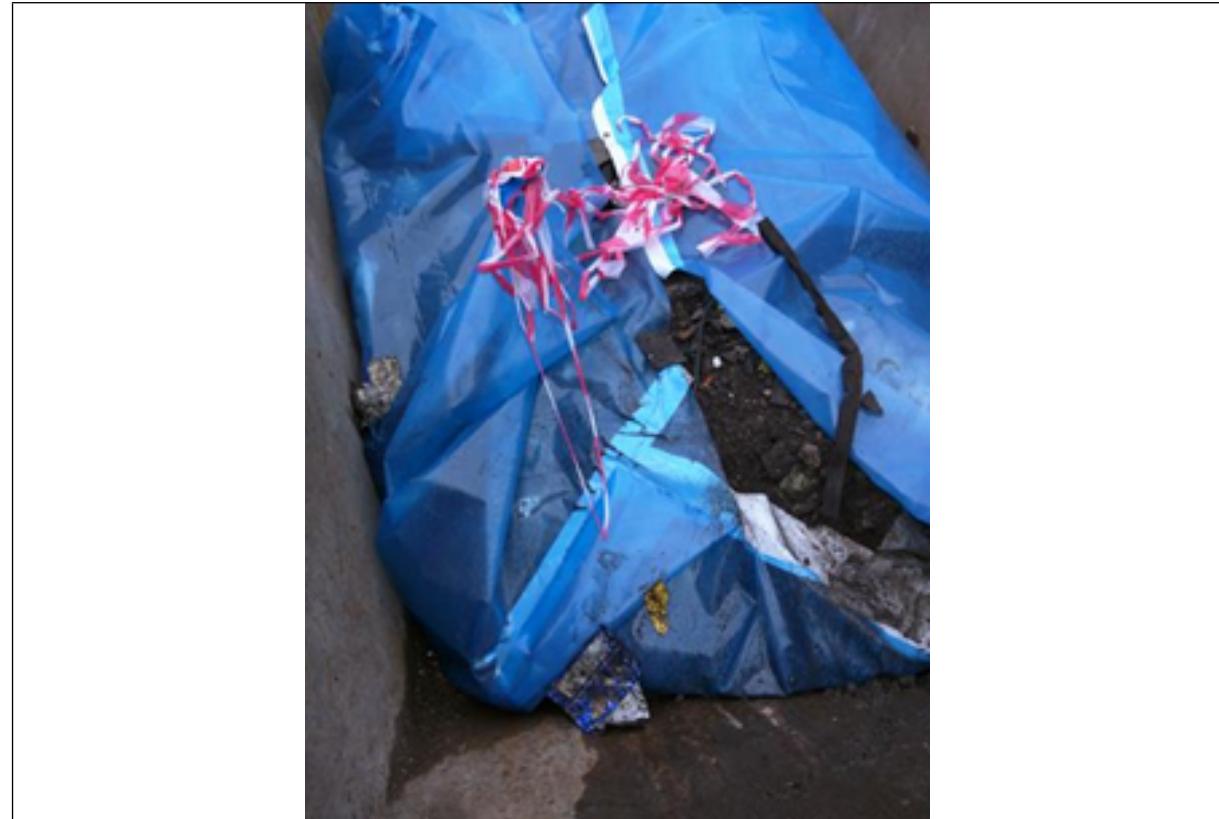
Asbestos Type	Chrysotile
Product Type	Cement Corrugated Sheet
Condition	Removed
Surface Treatment	Cement
Material Risk Score	N/A

Removed

Surveyors Comments
This debris has been removed under a hazardous waste consignment note, no further action required.

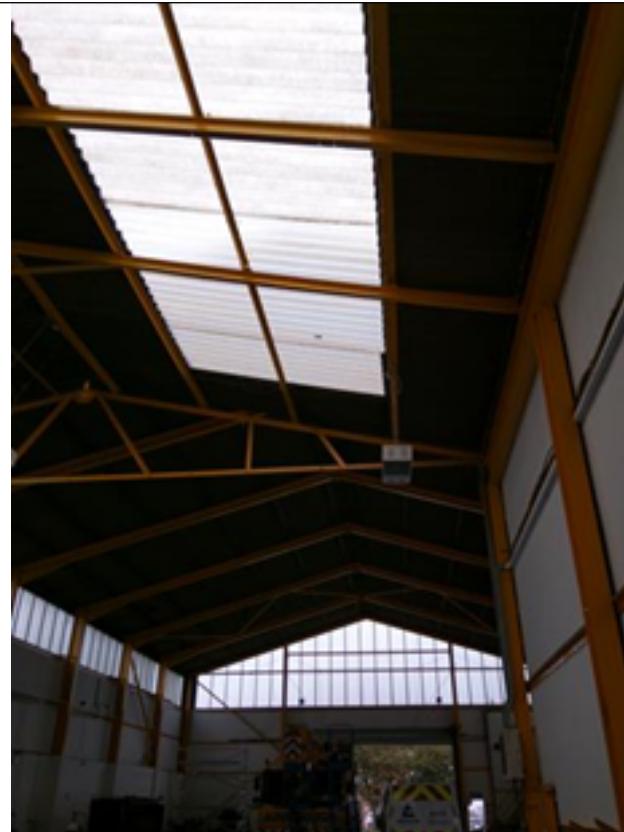
NST001

Asbestos Type	Presumed Chrysotile
Product Type	Cement Corrugated Sheet
Condition	Good Condition
Surface Treatment	Cement
Material Risk Score	3

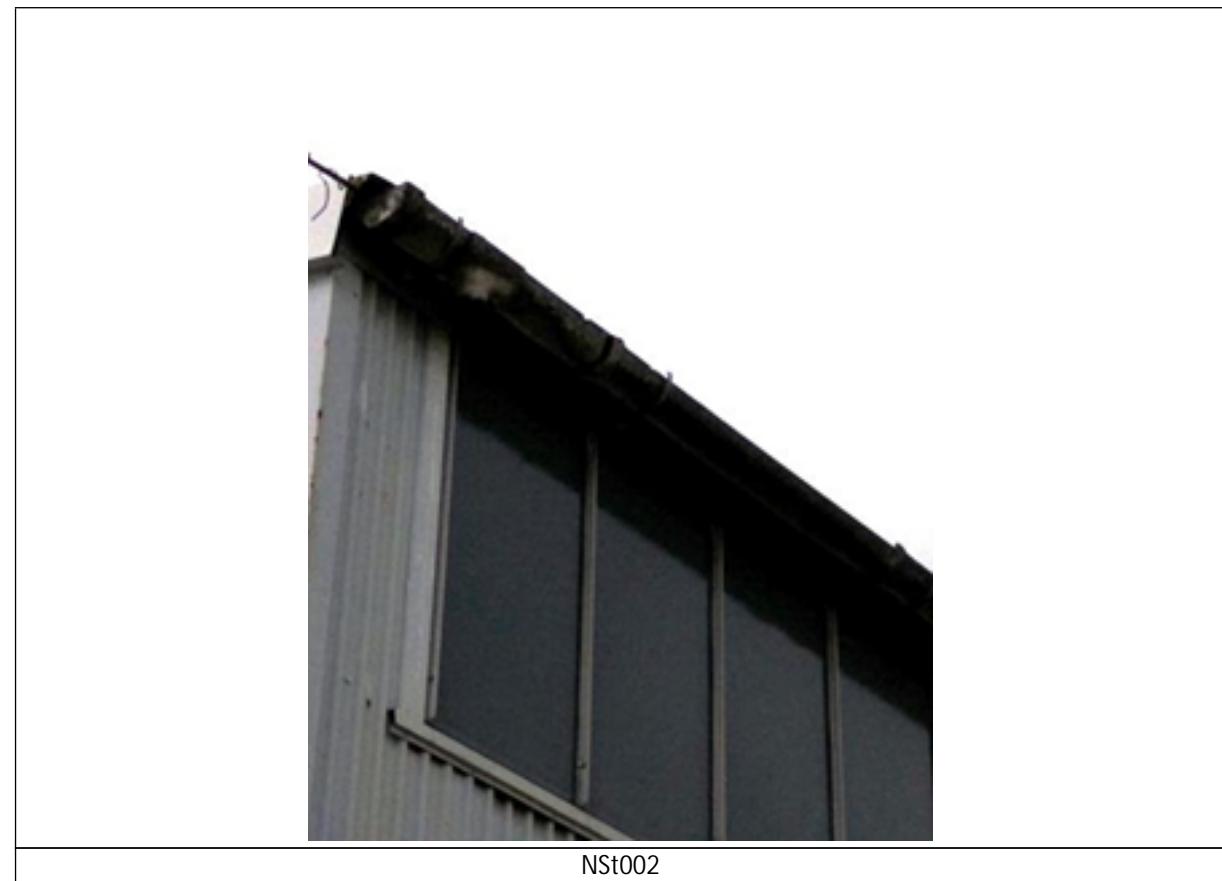
Asbestos Type	Presumed Chrysotile
Product Type	Cement Gutter
Condition	Low Damage
Surface Treatment	Cement
Material Risk Score	4

Surveyors Comments
This cement guttering, which is showing signs of wear, is presumed to contain asbestos as it was too high to access and sample. This should be managed on an annual basis via an asbestos management plan.

ASBESTOS WAS PRESUMED TO BE IN THIS SAMPLE

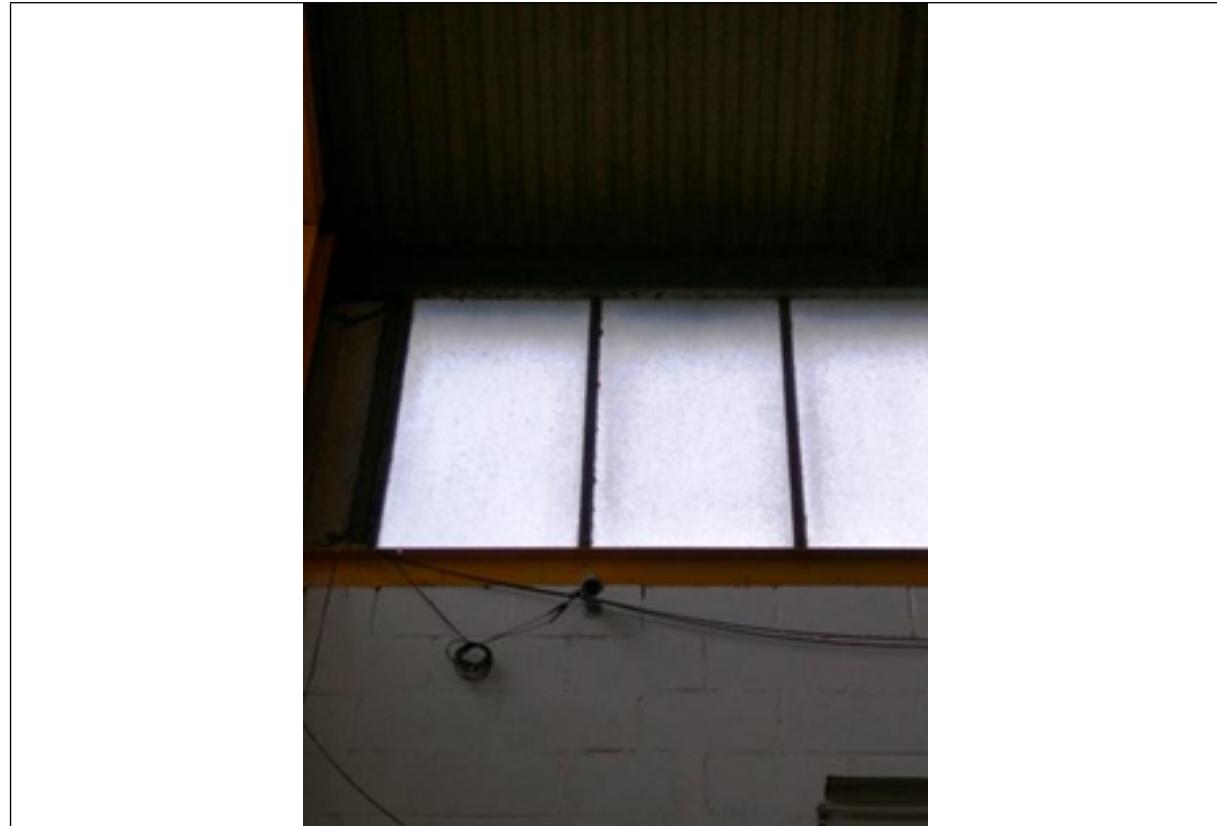
NST003

Asbestos Type	Presumed Chrysotile
Product Type	Rope
Condition	No Visible Damage
Surface Treatment	Fabric
Material Risk Score	4

Surveyors Comments
This window rope seal is presumed to contain asbestos as the windows were too high to access and sample. This should be managed on an annual basis via an asbestos management plan.

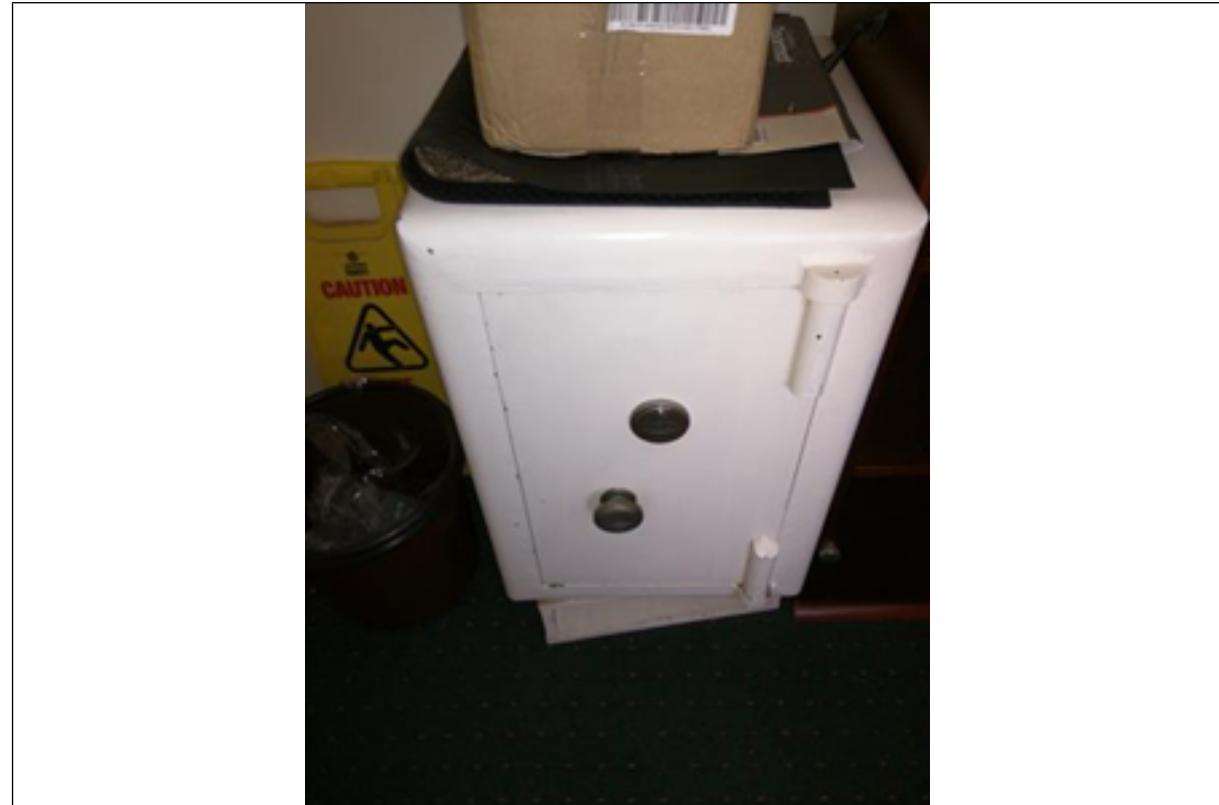
NST004

Asbestos Type	Presumed Chrysotile
Product Type	Rope Seal
Condition	No Visible Damage
Surface Treatment	Fabric
Material Risk Score	4

Surveyors Comments
This safe is presumed to contain asbestos as access was not possible. This should be managed on an annual basis via an asbestos management plan.
